Timeline:
2705326 – SR# 1298 – Facility ID # 009194
1910 N. State Route 89, Chino Valley, AZ
3/6/24

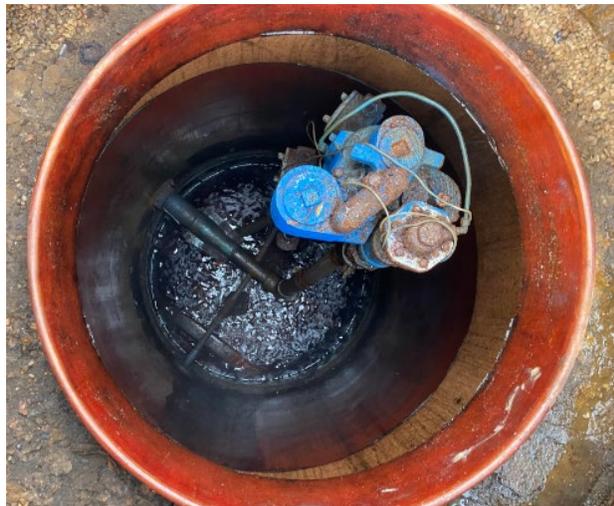
- **12/22/23**
 - Inspection Report completed and submitted into Circle K Data System (Titan).
 - Report based on 12/11/23 inspection indicates sensor in normal state; small amount of water in L3 sump (STP) area-see below.

Thus, Report did not register a concern with the STP.
