Geotechnical Investigation

Perkinsville 40

Perkinsville Road and Road 1E
Chino Valley, Arizona
ProTeX Job No.: 10413

Re: **Geotechnical Investigation**

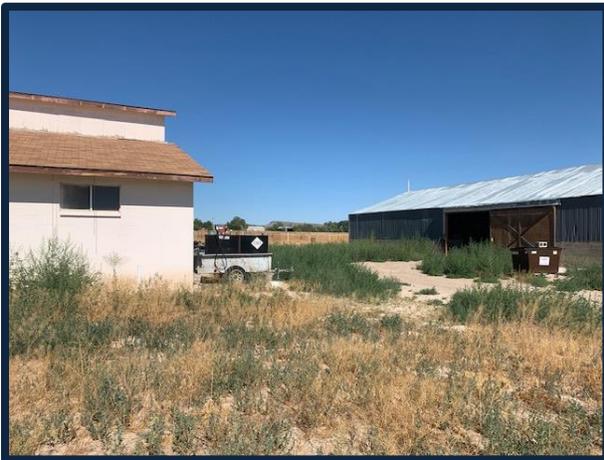
Figure 1: Existing structures on site

- Existing structures were located on site, including residential, wells house, storage, livestock and greenhouse structures
- Various water wells were located on site
- Two (2) trash pits were identified by the contact on site (See the site map in Appendix B for approximate locations)
- Underground utilities including power and water were located on the site
- Overhead power lines transverse from north to south along the alley road
- Moderate coverage of vegetation consisting mainly of grasses and small trees
- General slope and drainage of the site trends toward the north east direction

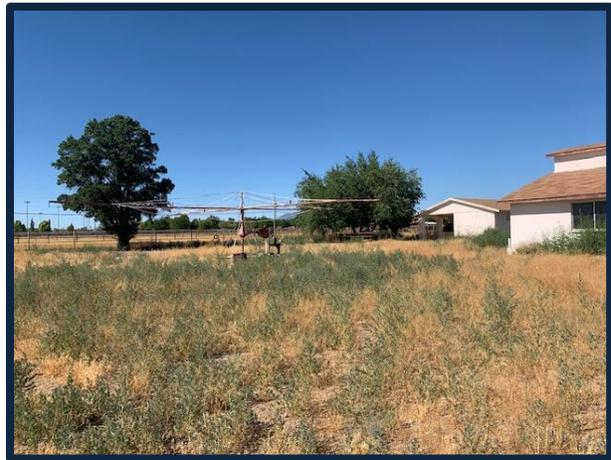
Figure 2: Existing Structures on site

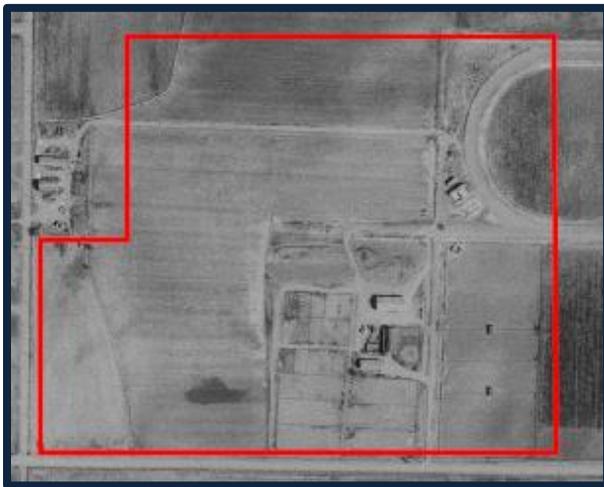
Figure 1: April of 1972

Former land use was identified on the property. Former land use included residential homes and storage/agricultural structures. Structures were present on the site prior to 1972.

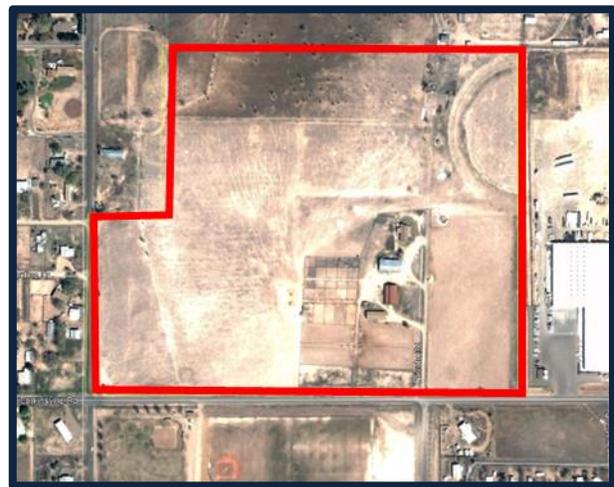
Figure 2: May of 2003

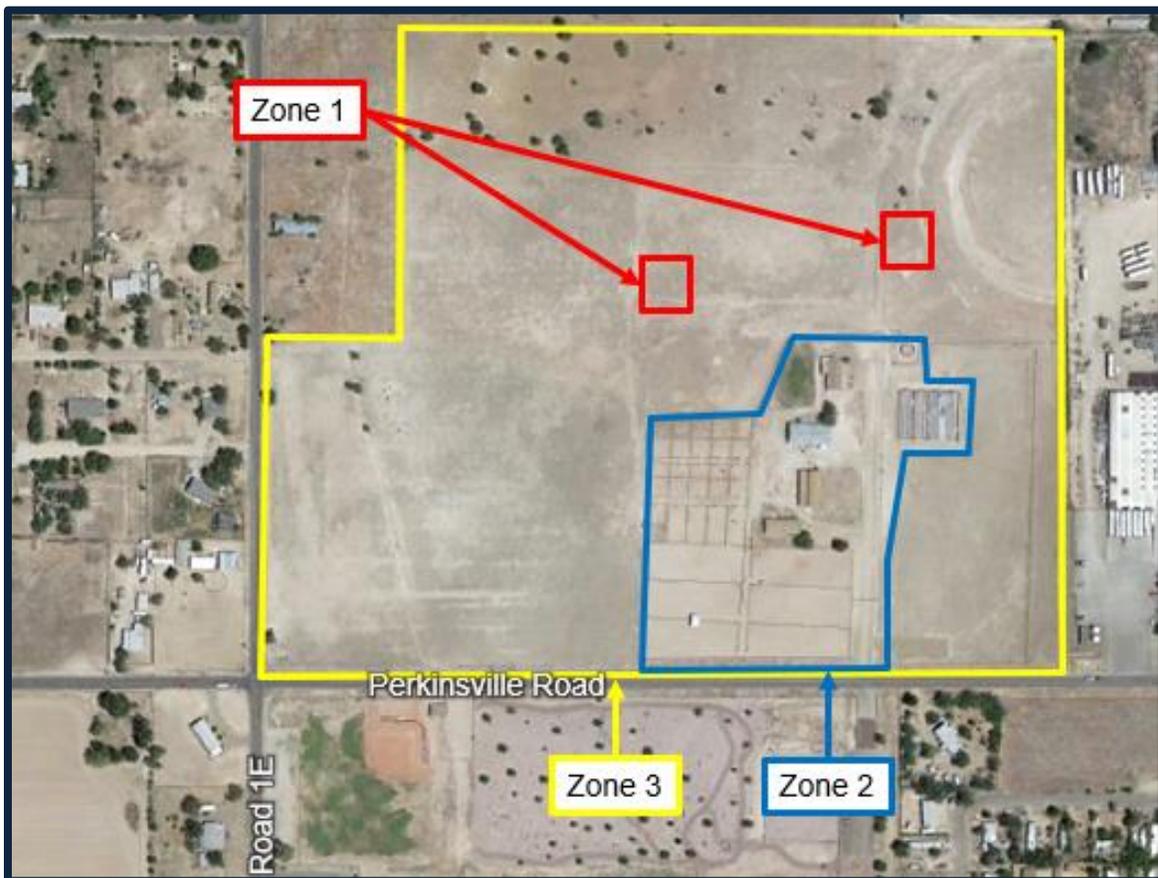
Due to the former development, the site has been divided into three (3) over excavation zones. See the map below for Over Excavation Zone designations.

Zone 1 (Red) – Trash Pit Area

Due to possible buried debris and/or undocumented fill, the surface soils should be over-excavated a minimum depth of 10.0 foot below existing grade or to firm native soils. Firm native soils should be verified by a representative of ProTeX prior to backfill. Additional investigation may be performed to further identify the area.

Due to loose/soft surface soils and site vegetation, the surface soils should be over-excavated a minimum depth of 1.0 foot below existing grade or 1.0 foot below final ad elevation, whichever is deeper.

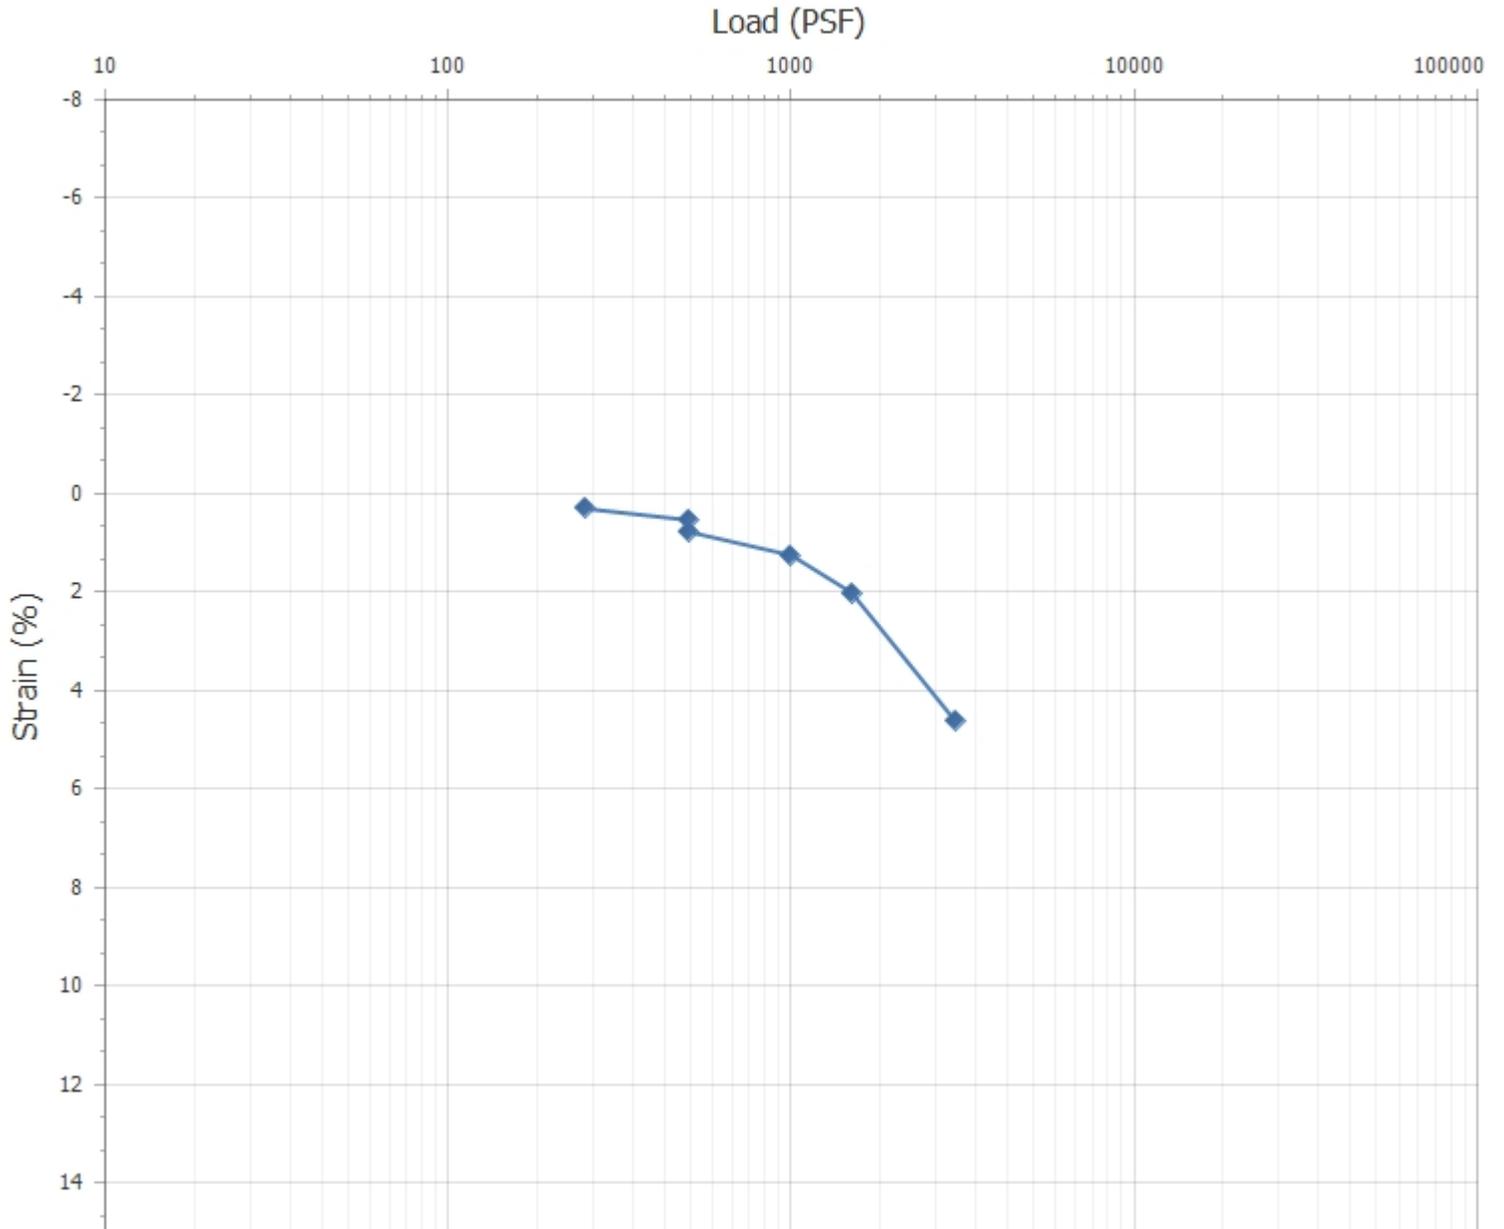
Source: B1 - Ring 1.5'

Moisture Content: 9.6 %

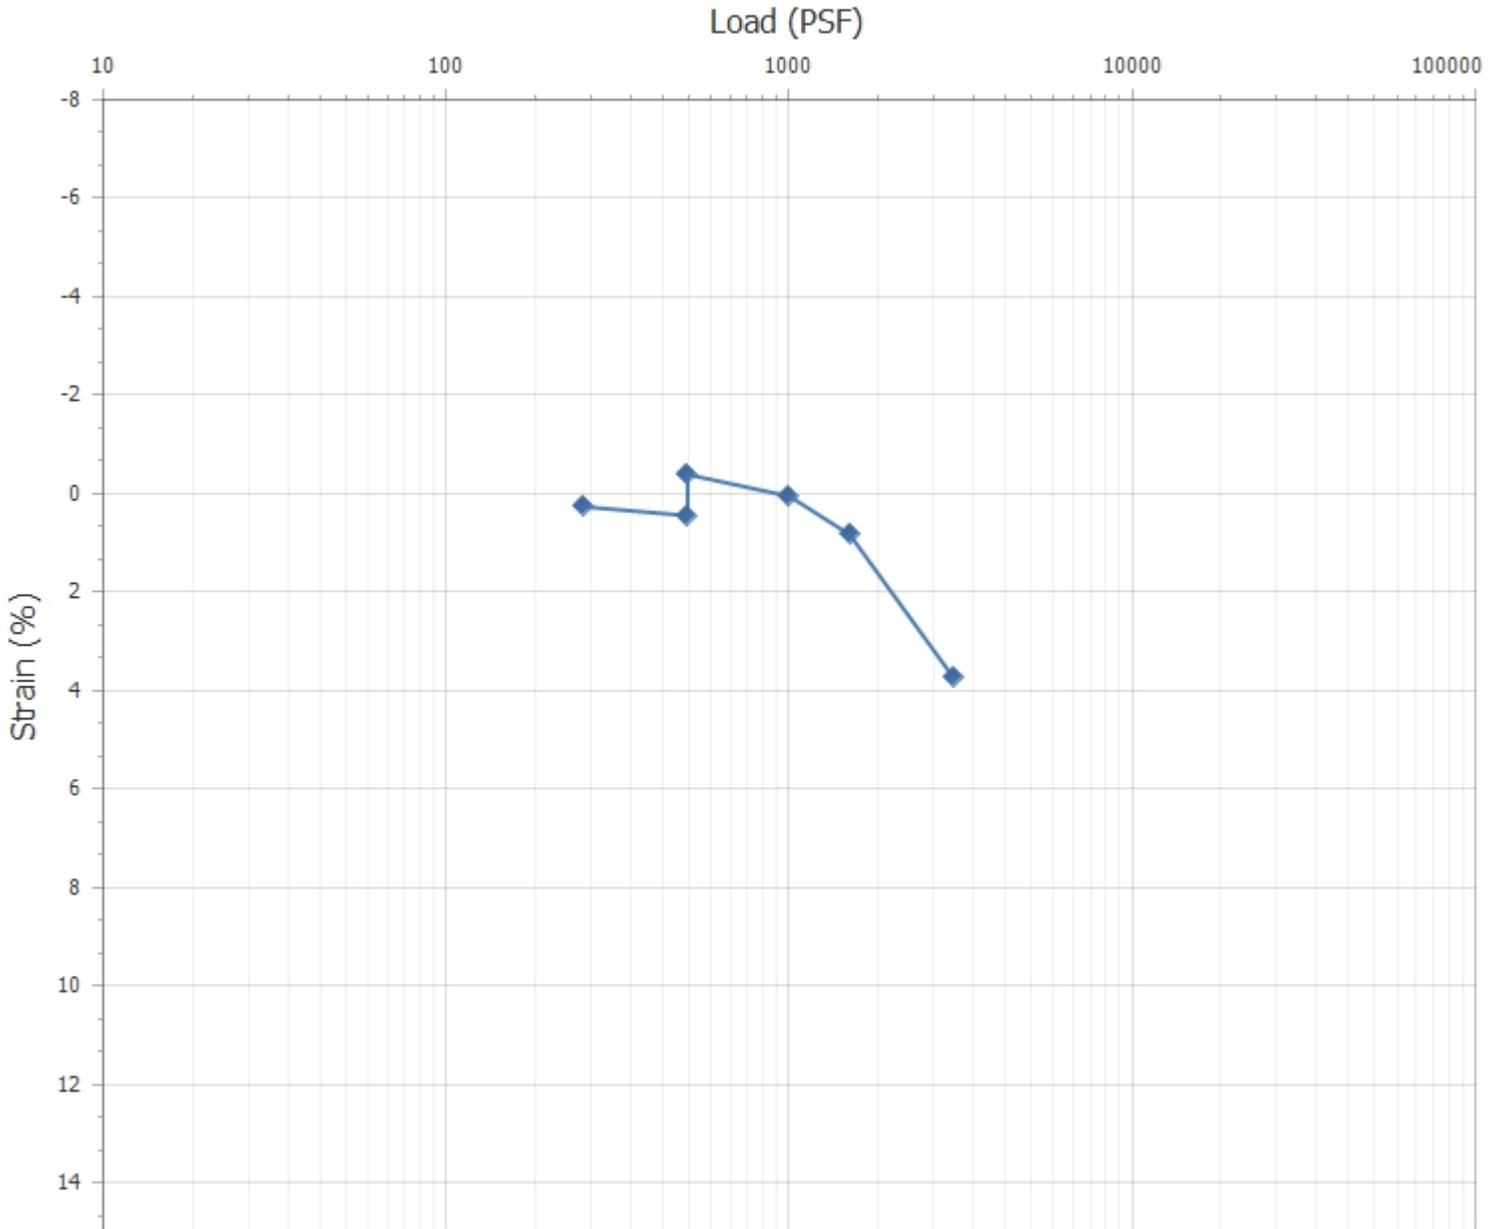
Source: B1 - Ring 5'

Moisture Content: 11.8 %

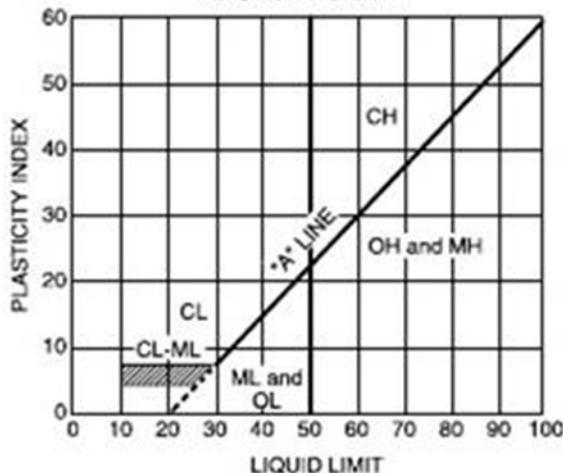
PLASTICITY CHART
